**E. SOUTHEAST**

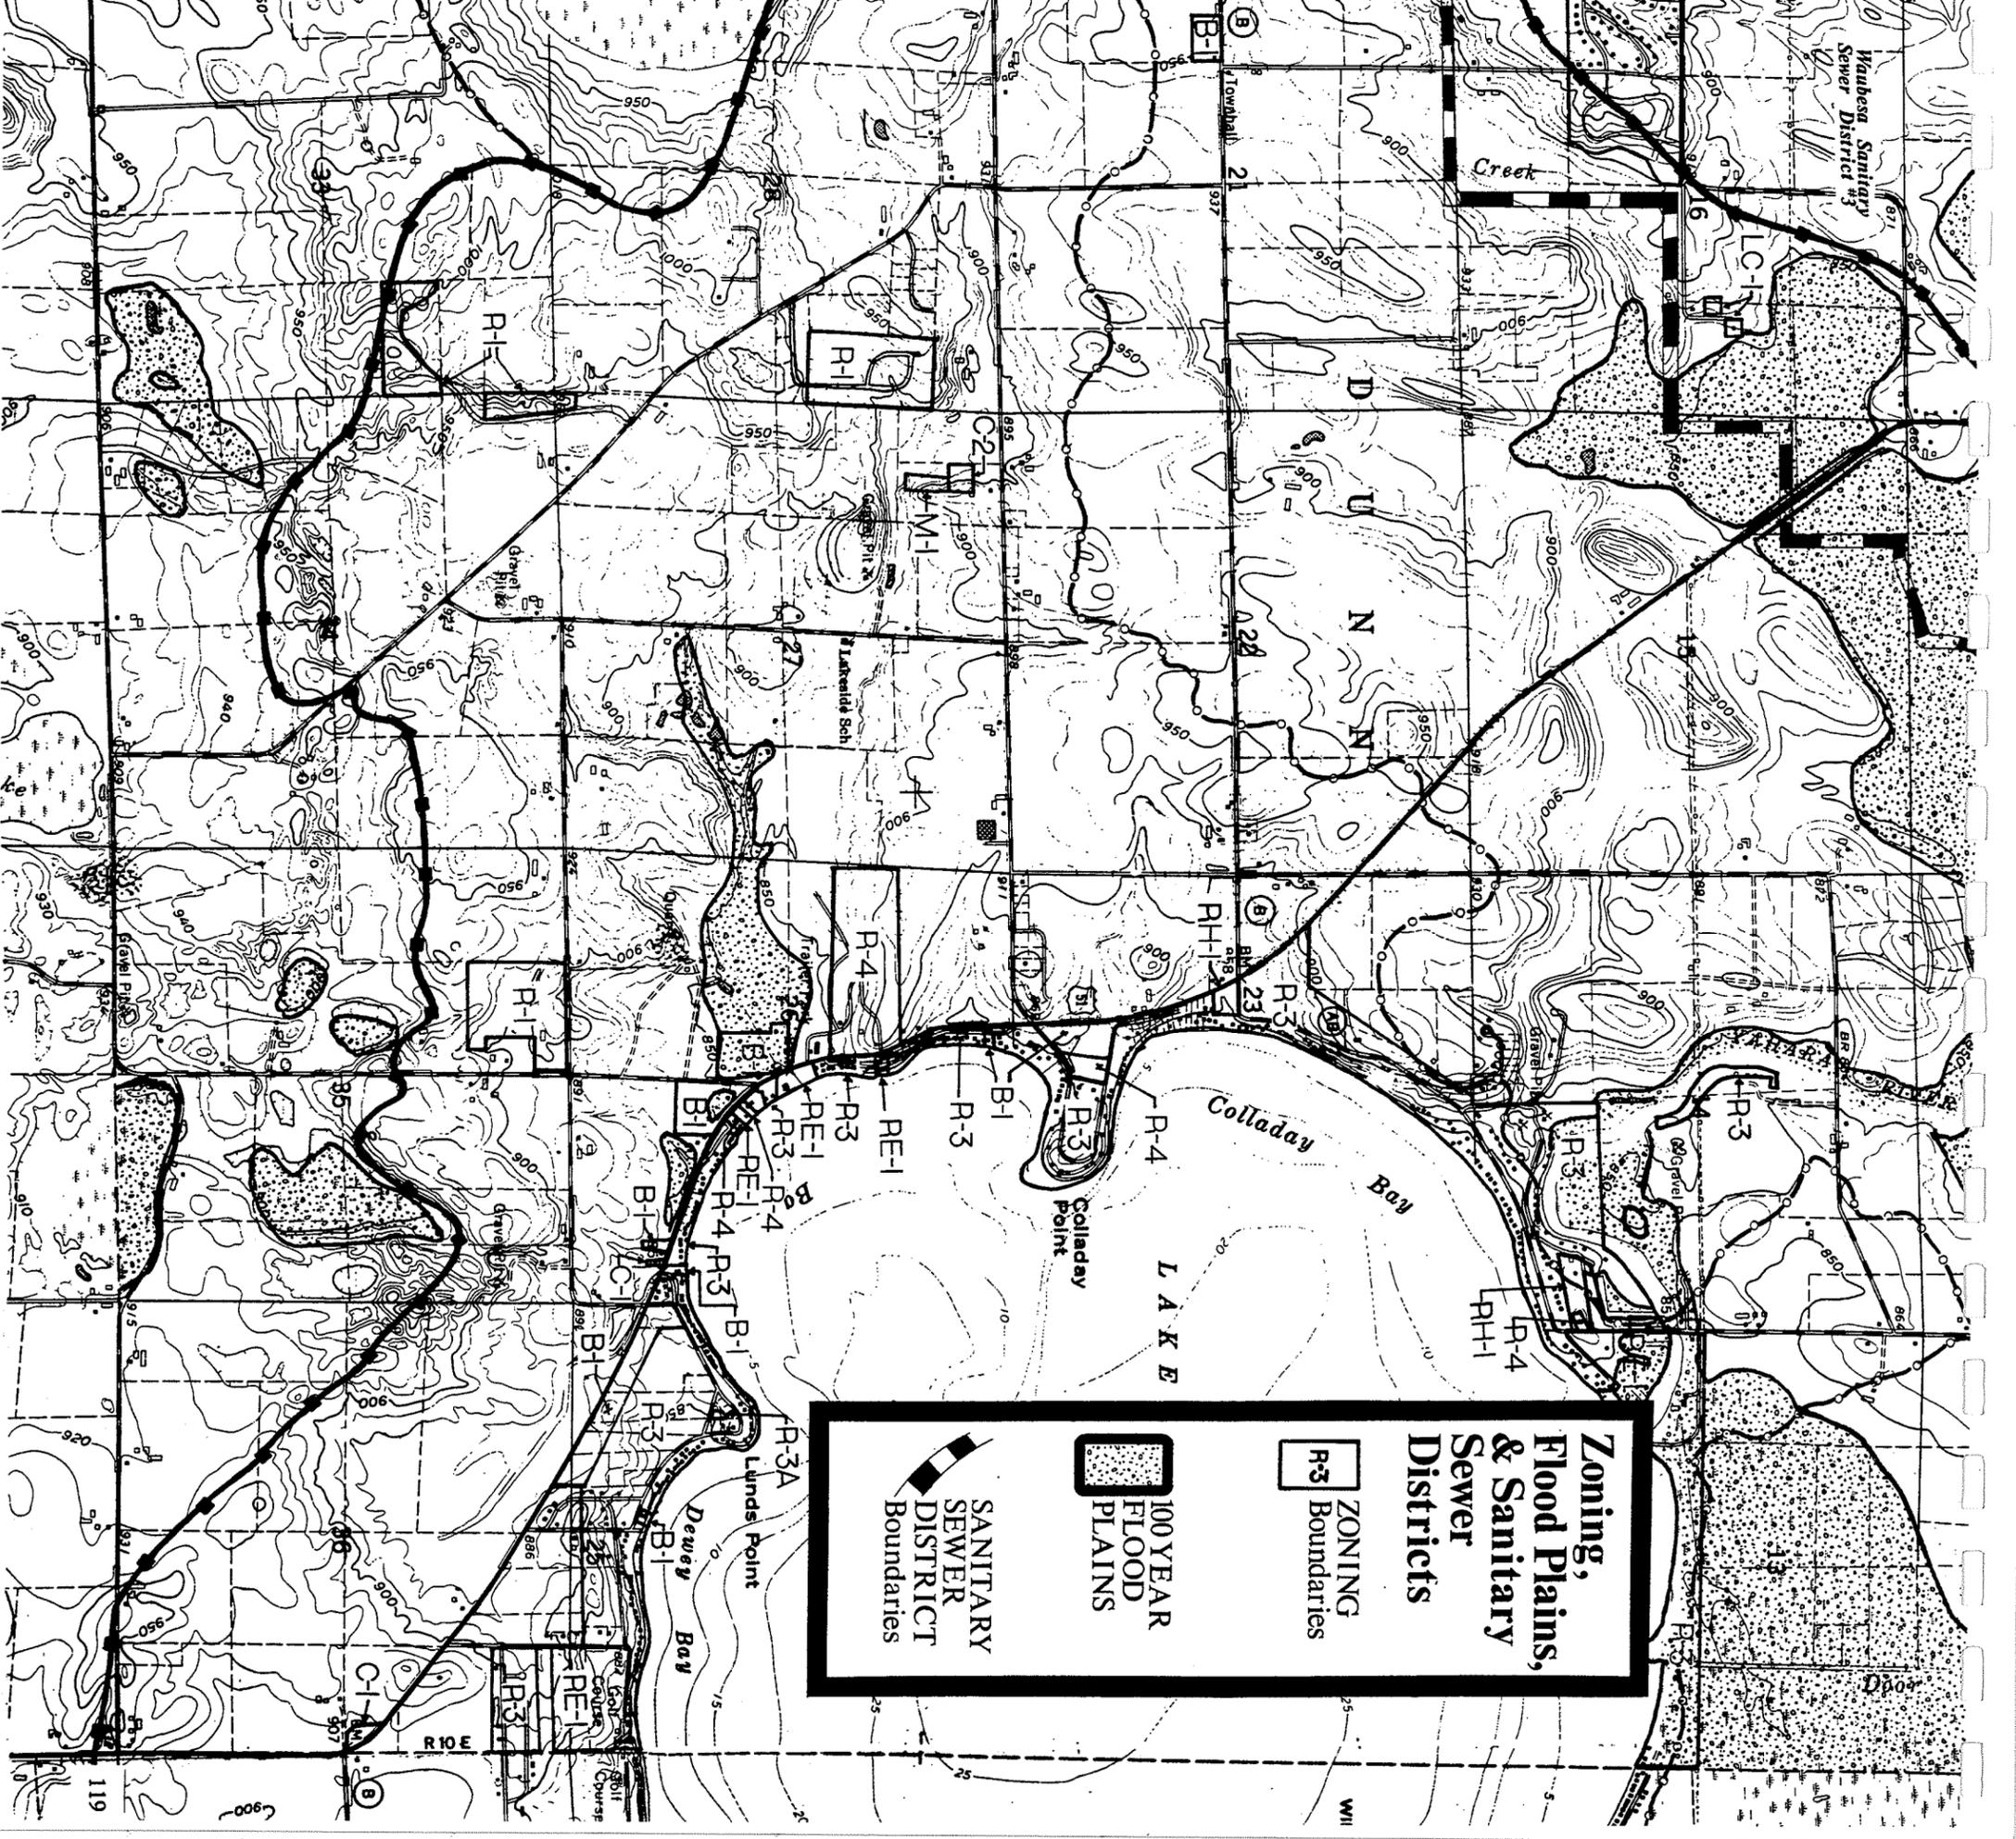
**Zoning,  
Flood Plains,  
& Sanitary  
Districts**

This study area includes most of the dense tier of development along the Lake Kegonsa shore. Although a sanitary sewer district exists in this area, its exact boundaries have not been determined as of this writing. The boundaries will generally conform to areas of existing development, in contrast to the expanded district boundaries in the Lake Waubesa area. The sewer system has not yet been constructed along Lake Kegonsa. Significant increases

in development along Lake Kegonsa would result in difficult service provision problems for the town due to the linear nature of the development pattern. This is especially true for such services as police and fire protection.

The 100-year flood plain areas include the wetland to the south of the mobile home park and several low and marshy areas near the southern border of the town.

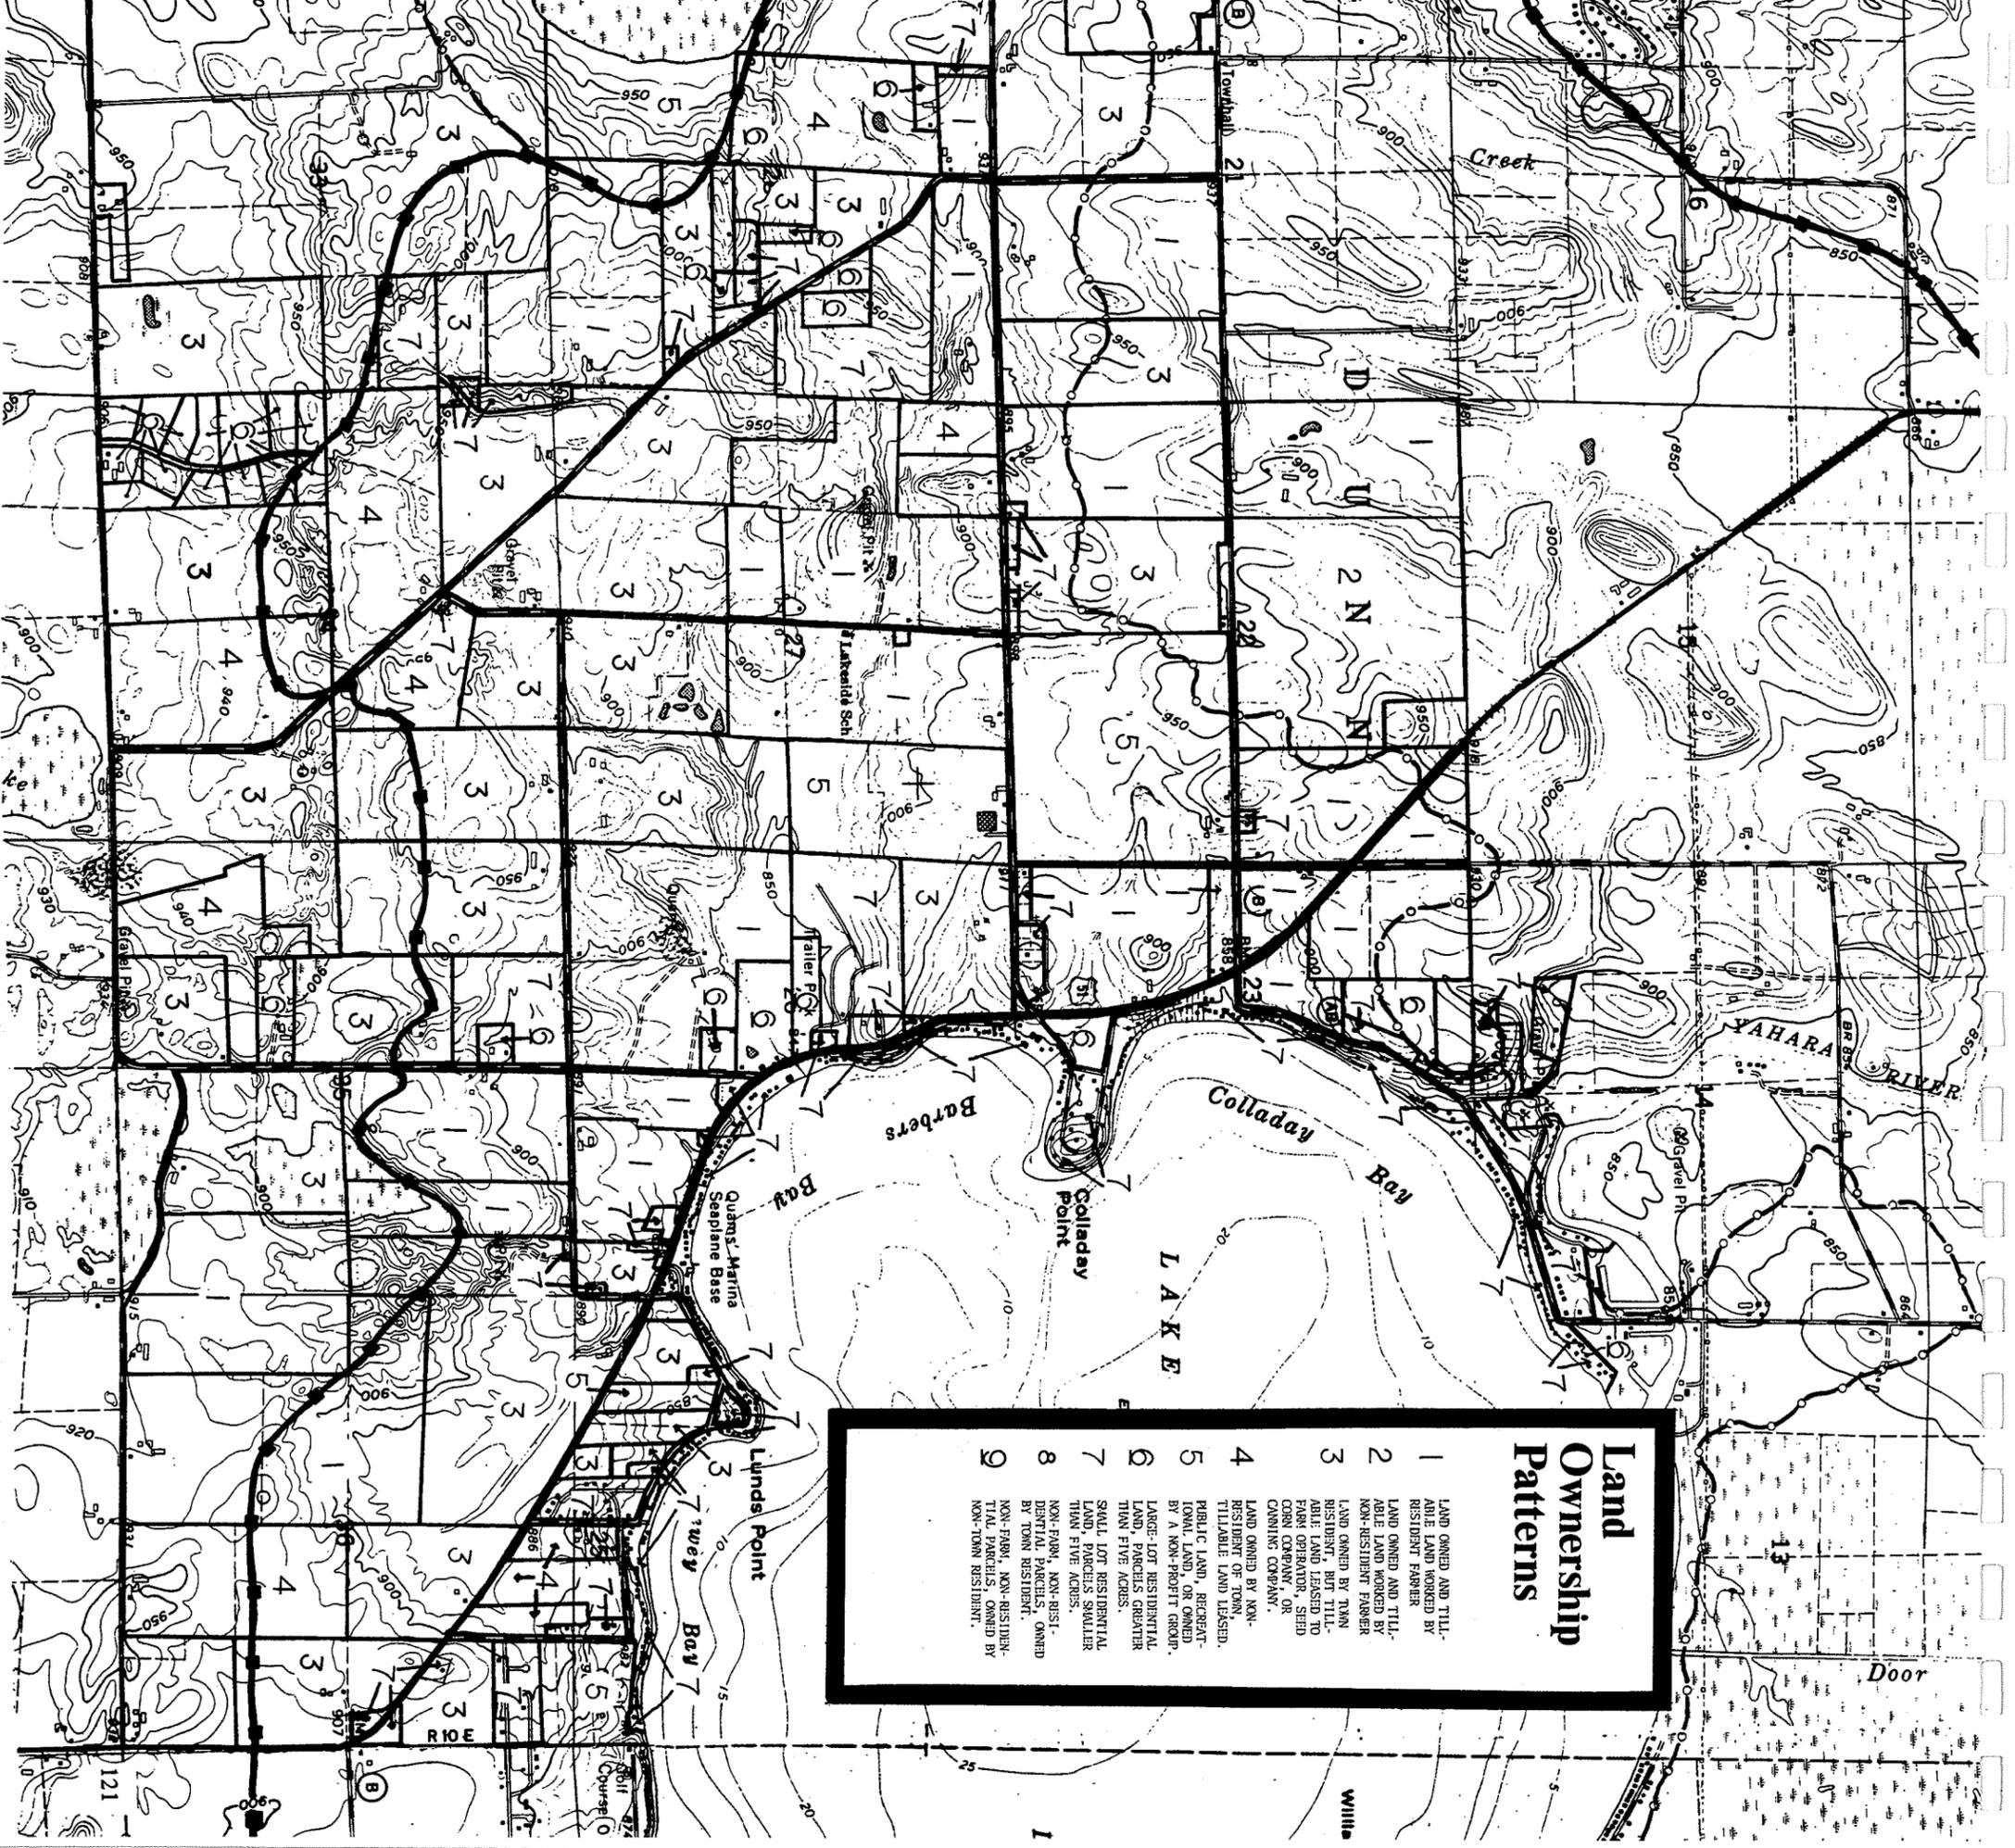
### Land Ownership Patterns

This study area contains a relatively high proportion of rented agricultural land. In addition to the development along Lake Kegonsa, several small lot development areas are found here, including three subdivisions and an 80 acre set of "farmettes" located along the southern border of the town. The University of Wisconsin owns 240 acres of land in sections 22 and 27.

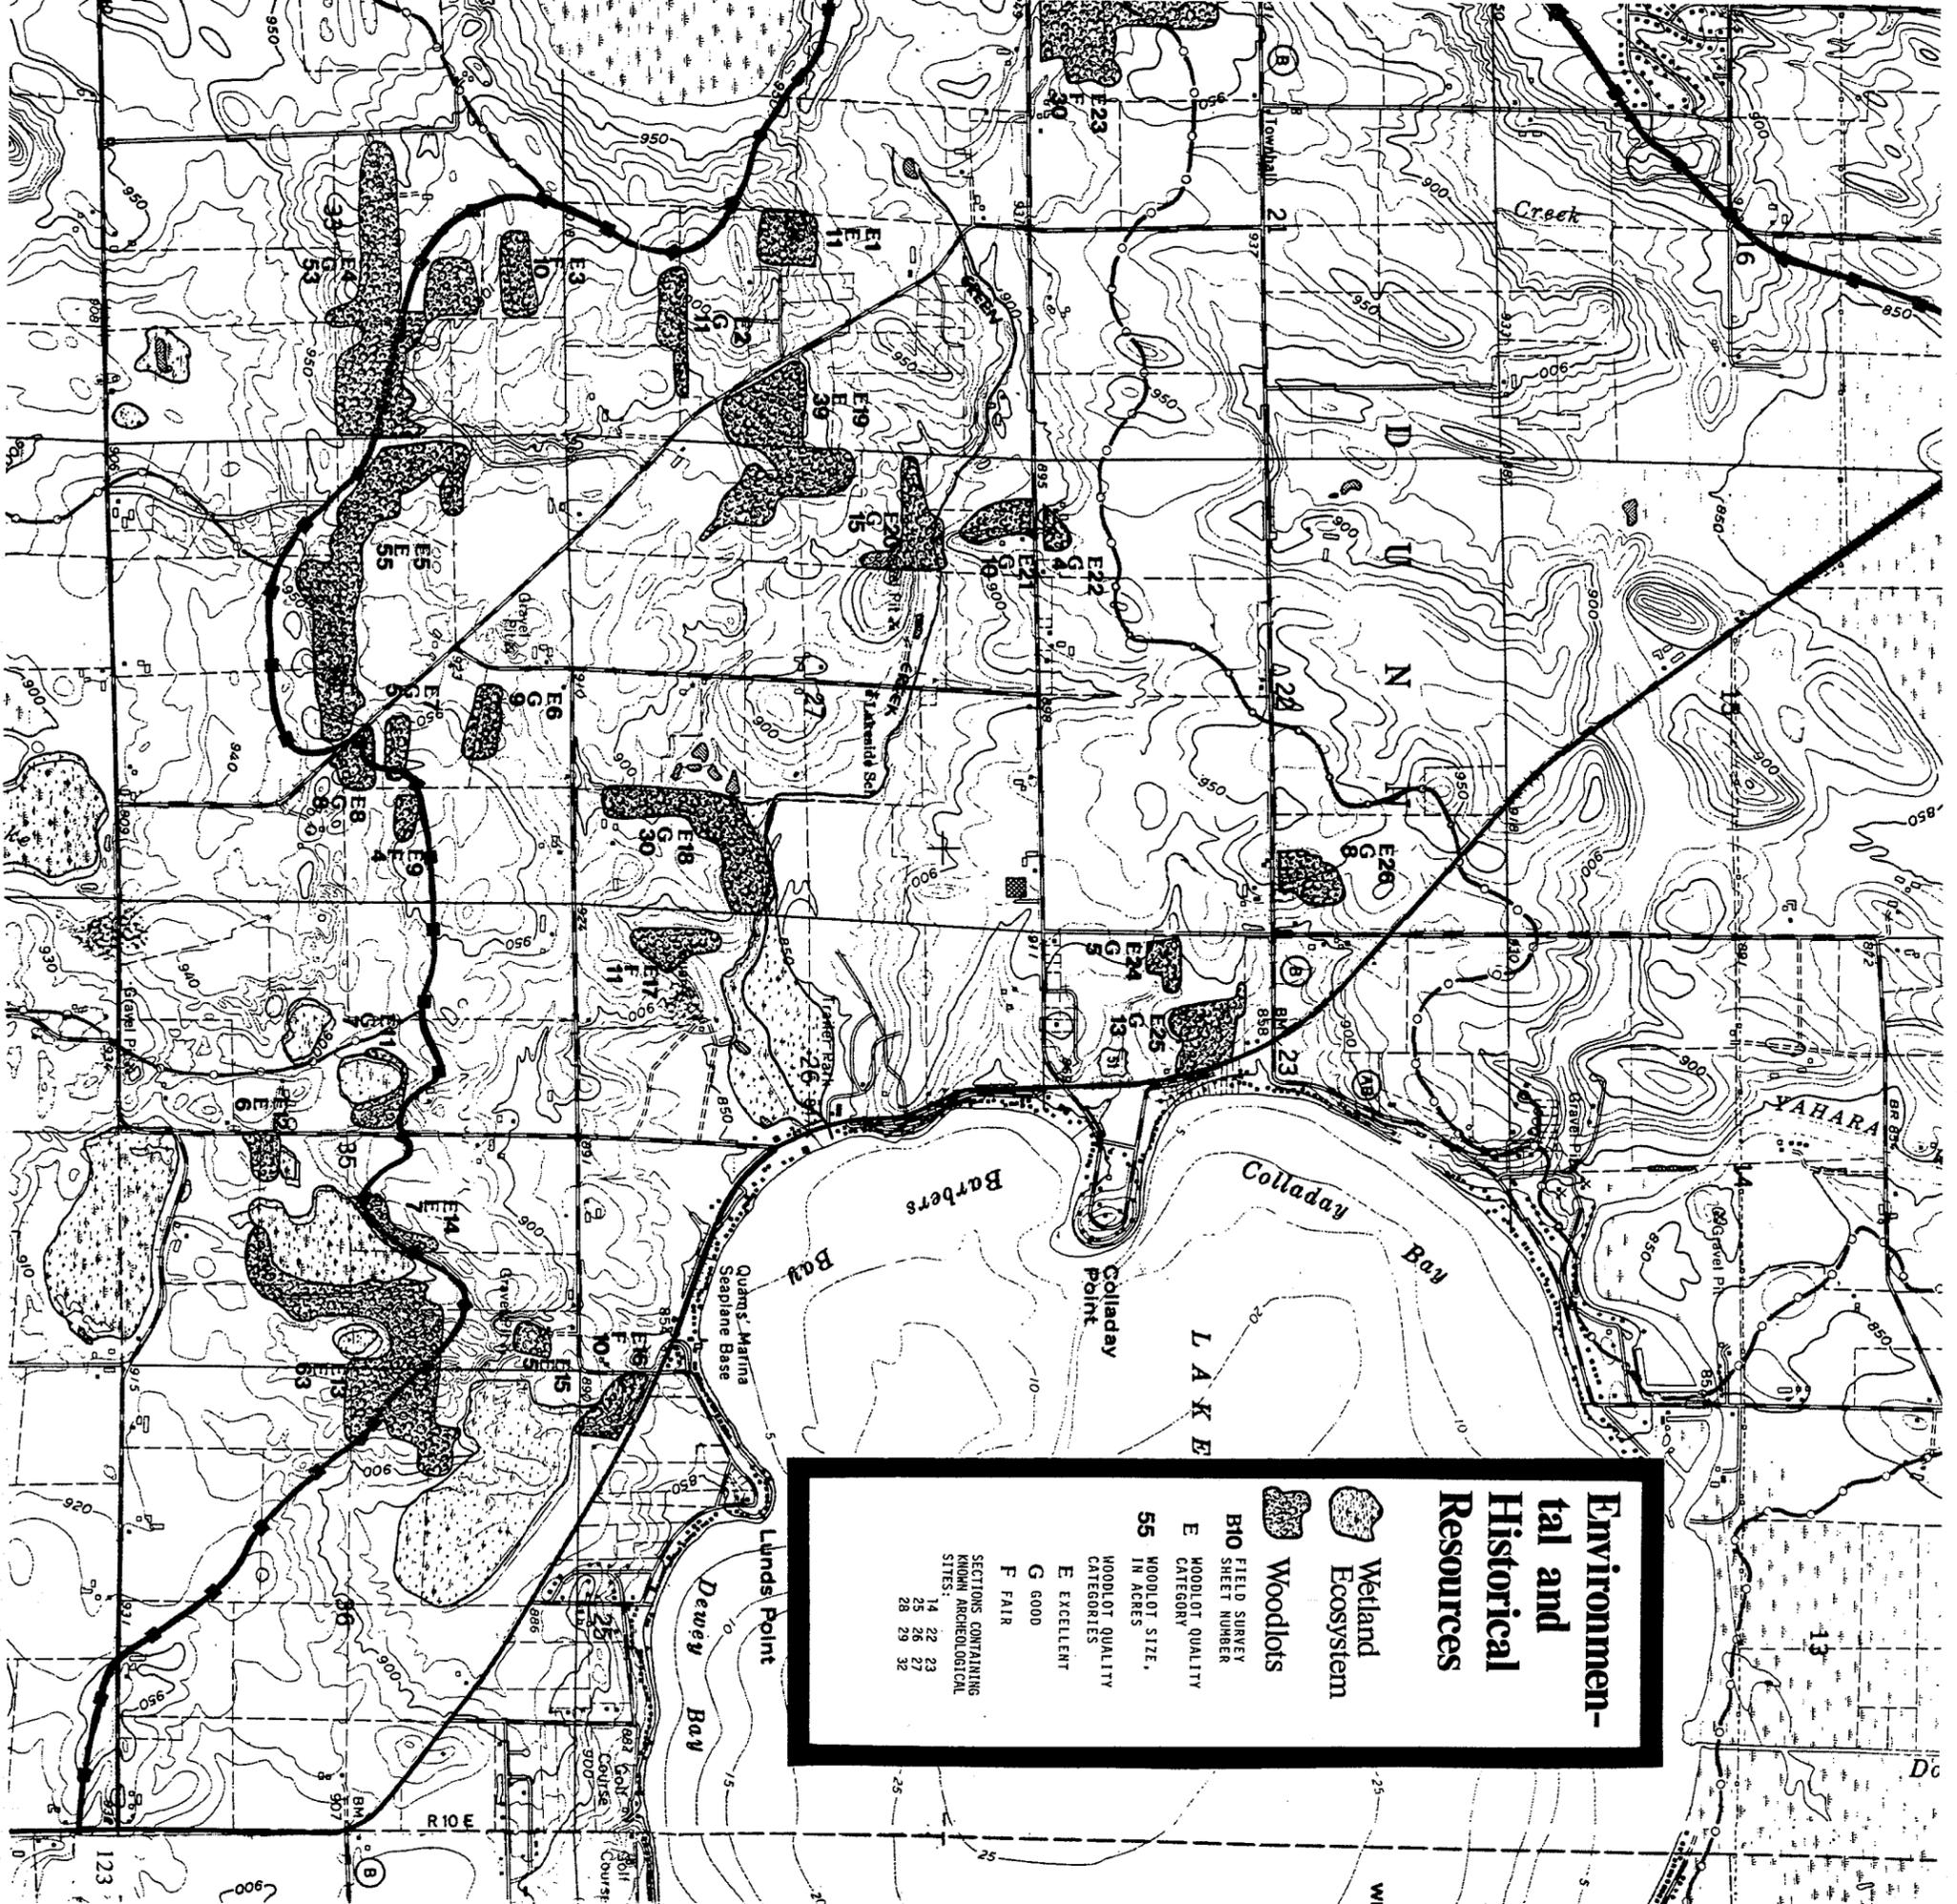
**Environmental and Historical Resources**

Of all the town study areas, this one contains the largest number of woodlots. The following is a brief description of the woodlots surveyed in Study Area E:

**B10** FIELD SURVEY SHEET NUMBER  
**E** WOODLOT QUALITY CATEGORY  
**55** WOODLOT SIZE, IN ACRES  
**WOODLOT QUALITY CATEGORIES**  
**G** GOOD  
**F** FAIR

**SECTIONS CONTAINING KNOWN ARCHEOLOGICAL SITES:**  
 14 22 23  
 25 26 27 32

Almost all of the known archaeological sites in this study area are found near the shore of Lake Kegonsa. In the 1925 survey conducted by W. G. McLachlan, four village sites and eight groups of Indian mounds were located in this area. In 1925 McLachlan stated that, "Each decade witnesses the destruction not only of single mounds, but the obliteration of whole groups. Scarcely a person is living who saw them when undisturbed." Since then more mounds and mound groups have been lost. Hopefully town residents will work to prevent the further loss of these irreplaceable resources.

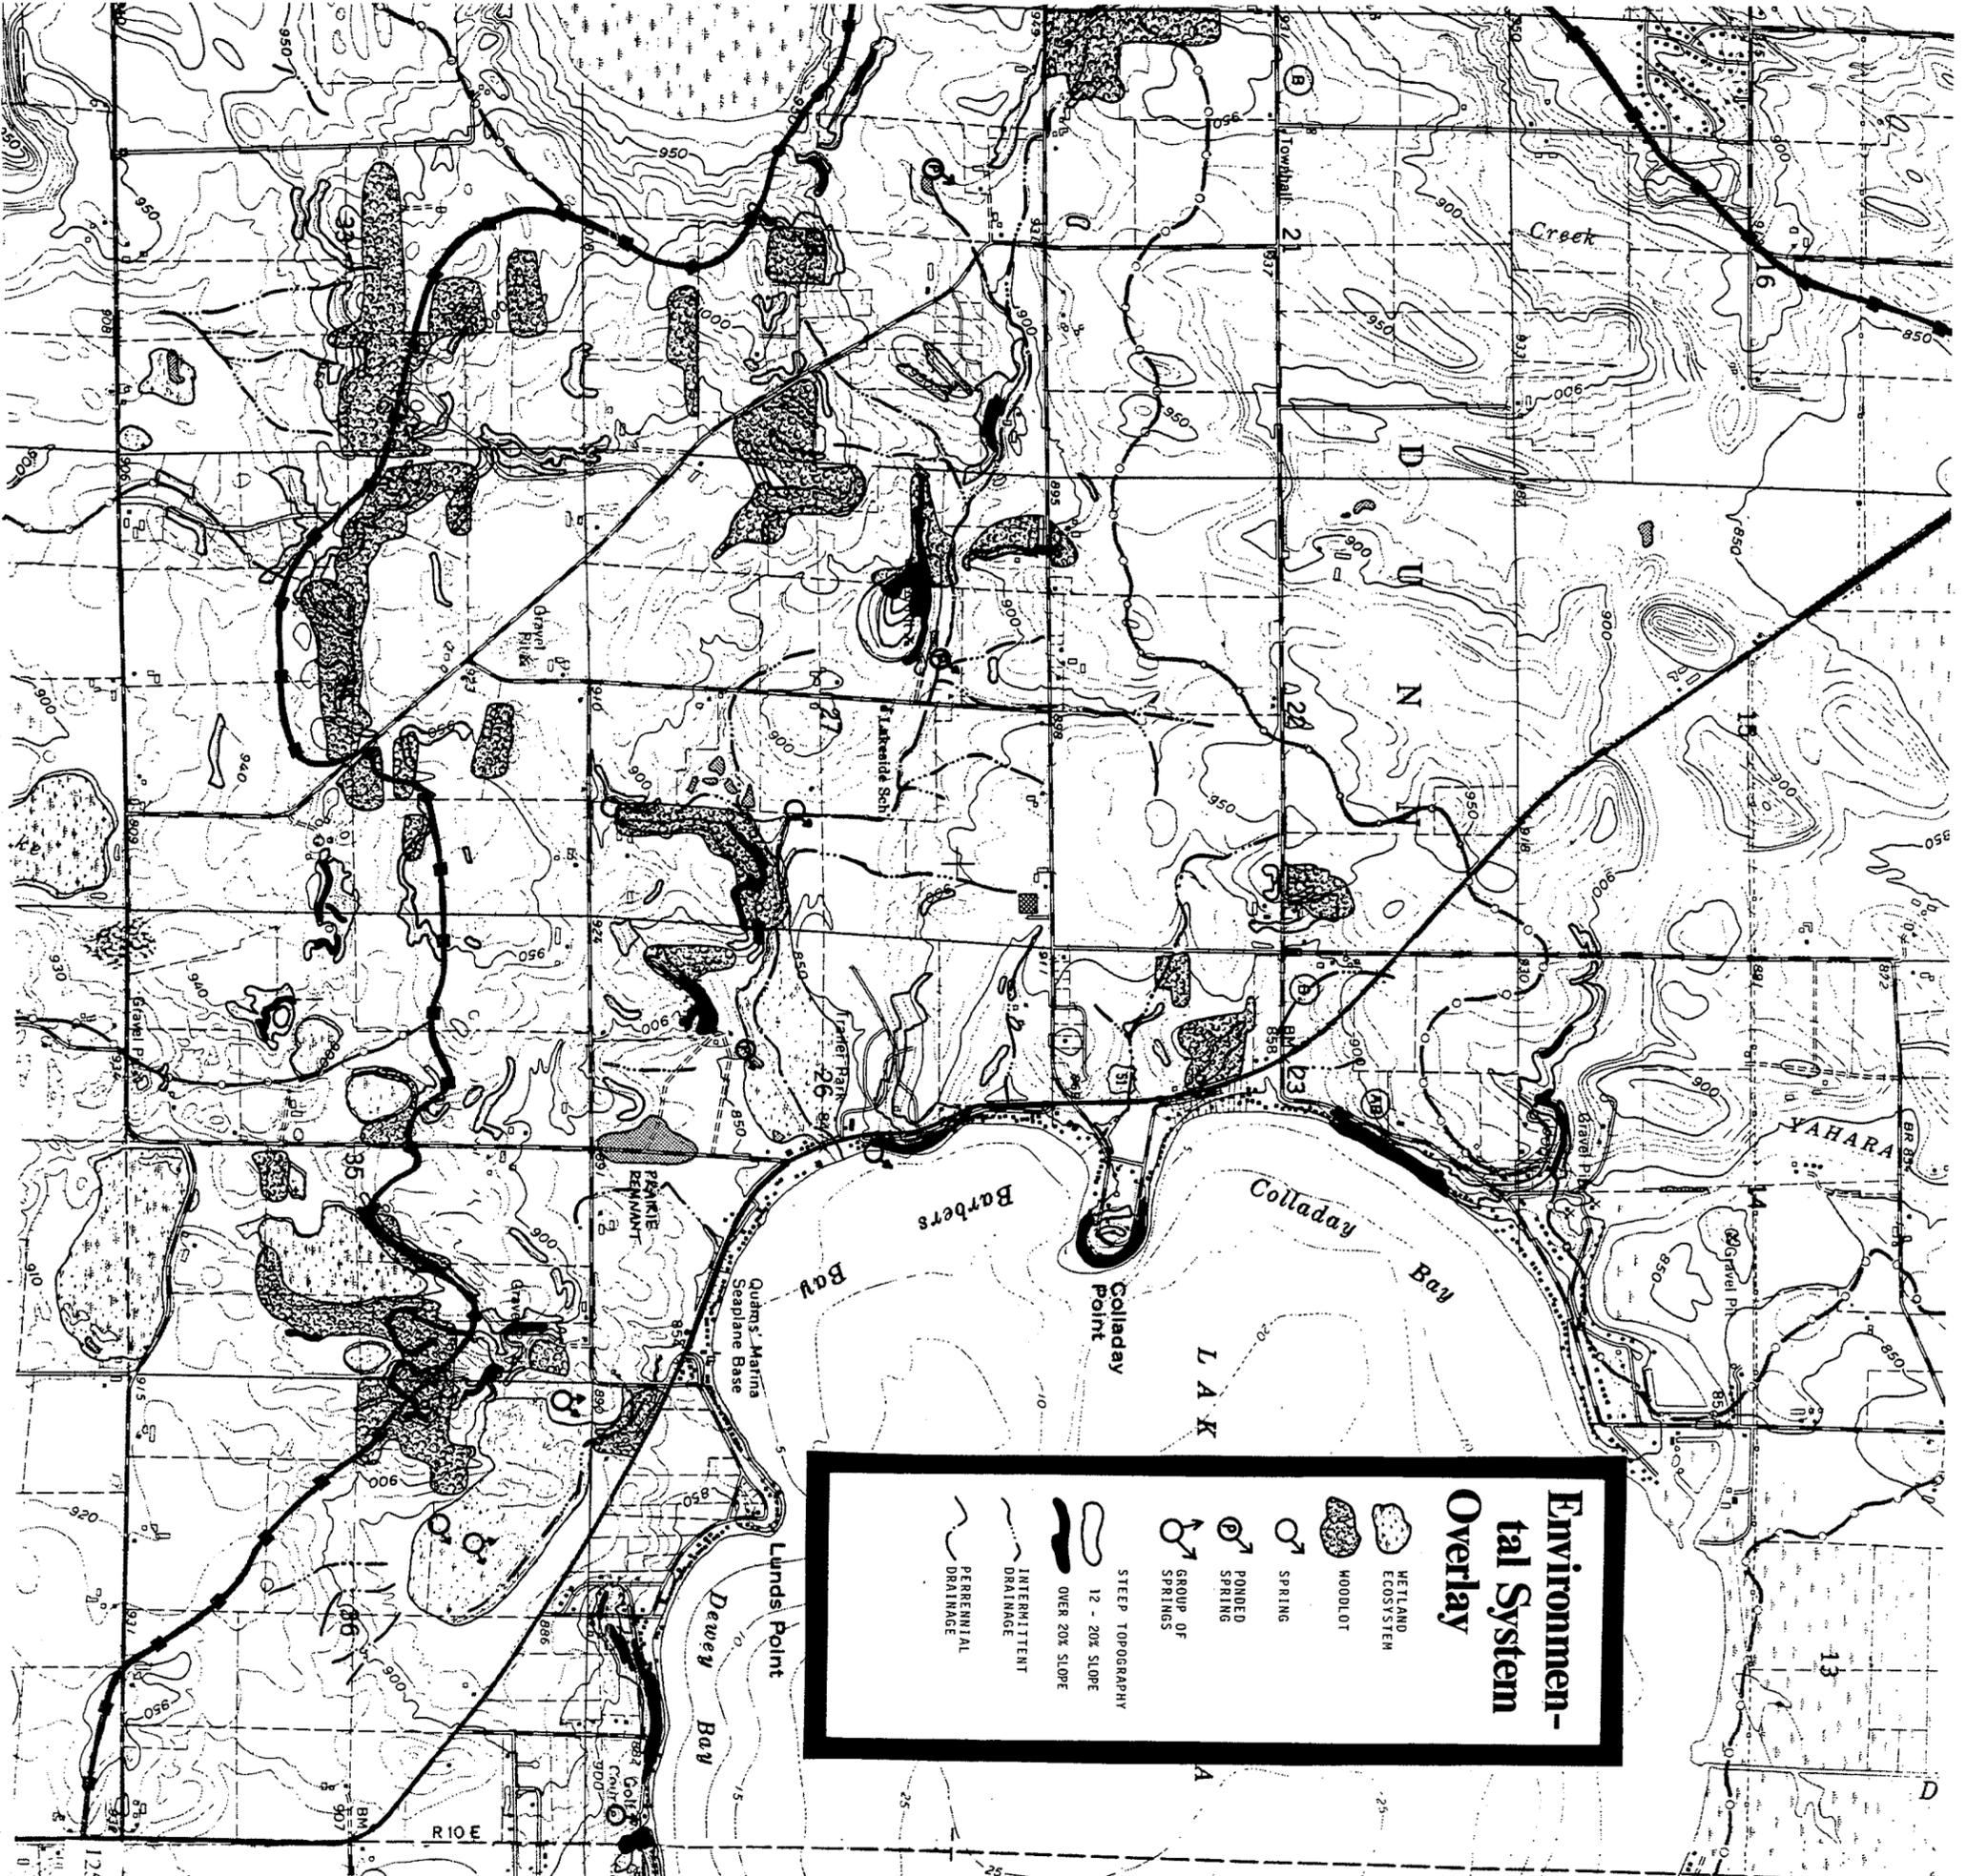
**Environmental System Overlay**

This map clearly shows the upper, middle and lower areas within the overall study area. The upper area consists of discontinuous woodlots, steep slopes and drainage channels that empty into Lake Kegonsa. The middle area has Green Creek at its center, linking a system of woodlots, steep slopes, drainage channels, springs and wetlands. The lower area consists of a line of woodlots, steep slopes, kettle-hole marshes and springs, all linked by a ridge formed by the glacial moraine.

The irregular steep topography patterns in the lower part of this area are characteristic of glacial moraine topography. The topography and drainage pattern in the middle and upper parts is more well-defined.

Runoff in the upper part of the area runs directly into Lake Kegonsa. The drainage channel that runs into the lake directly south of Colladay Point has been a problem to the town and to the residents of that area. This problem should serve as an example of the need for adequate stormwater management planning in the future.

Proper uplands land use management is important to the maintenance of the western shoreline of Lake Kegonsa. The water depth lines in Lake Kegonsa show that it is a shallow lake. Sedimentation occurring over a number of years at drainage discharge points could result in some shoreland areas filling in.

The middle part of this study area consists of the Green Creek drainage basin. This creek is fed by several springs along its course. Several more springs and seepages are found south of Lake Kegonsa and Highway 51. The spring water moves from there into the lake, providing a source of clean water. The higher elevations in the lower part of this study area serve as an aquifer recharge area.
